### Clarence Excavation and Rapid Recording, April/May 2012

## J5 Submarine Anode Protection Project

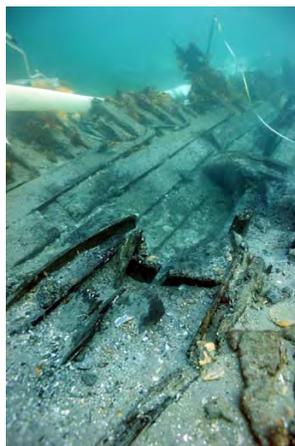
View to stern of the excavation trench, starboard side of *Clarence*. (Photo by Deb Shefi)

The team excavated a starboard section of *Clarence* that extended from the stern some 11m along datums towards the bow, ending just aft of a large mast-step and leaving approximately 5m forward of this unexcavated. Although this remaining area was excavated in the 1980s, the substantial lower clay unit beneath the comparatively unconsolidated marine sediments (now known to be pipe clay or kaolinite ballast) was left in situ. The decision to cease excavation at this point was in recognition of days lost due to inclement weather and the re-scoping of reburial and conservation tasks. The excavation also took longer than predicted, given the plasticity, weight and additional labour required to remove this very significant clay unit. The volume of deposit excavated, area of timbers exposed and size of the
